SRF Materials Lab

# Eddy Current Scanning at Fermilab

C. Boffo, P. Bauer, M. Foley, FNAL, Batavia, IL 60510, U.S.A.

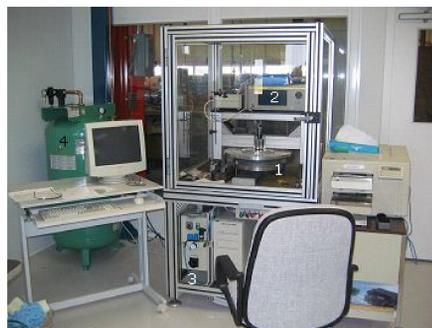
Eddy Current Scanner – on loan from SNS -

Fermilab has received and further upgraded a commercial eddy current scanner previously used for the SNS project. The upgrading process included the development a new filtering software. This scanner is now used on daily basis to scan the niobium sheets for the Fermilab third harmonic and transverse deflecting cavities.

Scanning disks is part of the QC process during SRF cavities production:

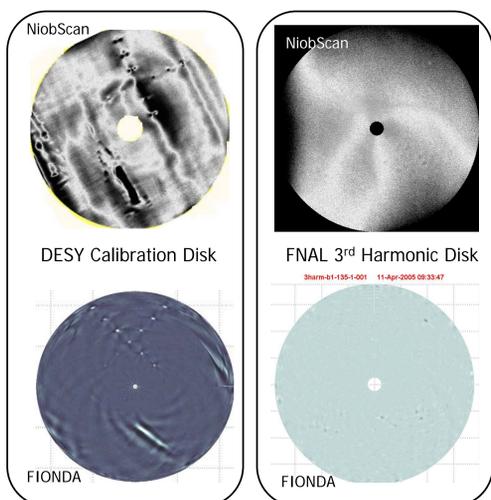
The DESY calibration disc is a ~0.1" thick, ~10" square niobium sheet supplied by the Wah-Chang company. It contains eleven implanted sub-surface defects. The figure on the left shows where the defects are located. Most defects are drilled holes of varying diameter, stuffed with Ta powder. The Ta was subsequently melted and the holes closed by superficial e-beam welding in vacuum. Holes 6 and 11 were not filled. The diameter of the holes varies between 120 and 230  $\mu\text{m}$ . The drilling depths vary between 80 and 500  $\mu\text{m}$ . The exact diameter and depth parameters for each hole are listed. Following the preparation of the implants the sheet was chemically polished.

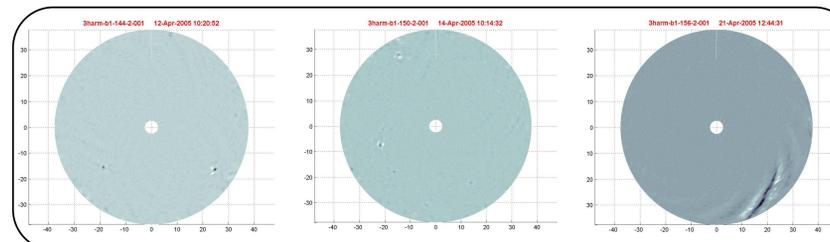
Typical defects: pits (left – center) and roller marks (right)

The ECS, after optimization, was employed to scan up 90 disks to be used for the production of 6 FNAL 3rd harmonic cavities. Each disk was visually inspected on both sides using a magnifying glass, afterwards it was scanned and the results filtered. The results can be summarized as follows: out of the 90 discs, 21 (23%) give no defect related signal and 22 discs (25%) give signals on both sides; 69 discs (76%) have at least one side giving a signal. 74 sides (41%) have visible pits (of which only 25% appear in the eddy current scans), 112 sides (62%) have scratches, and 27 sides (15%) have roller marks (which only appear in the eddy current scans).

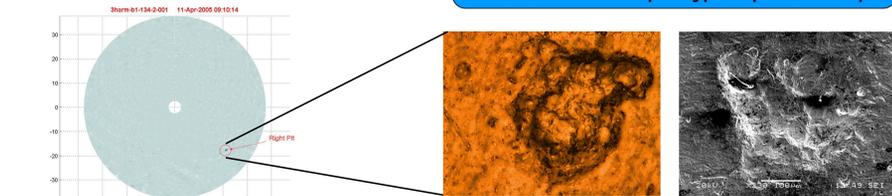
Optical and EDS pictures of a pit

Profilometric measurements were introduced to characterize the pits present on the surface of the disks. Measurements were performed on six disks presenting several pits each, using a Taylor Hobson Talysurf Intra device equipped with a 2  $\mu\text{m}$  radius diamond chisel. The measured pits dimensions varied between 0.2 and 0.5 mm in diameter and between 10 and 90  $\mu\text{m}$  in depth. The rich topology of the profile suggests that these pits could be the result of imprinting of grains, previously detached from the Niobium, sticking into the cylinders during the rolling process. Additional chemical analysis of the first micron on the surface of the pits using EDX confirmed that the chemical composition of these craters is the same as the rest of the disk. BCP tests showed that these pits are not always removed during the chemical process.

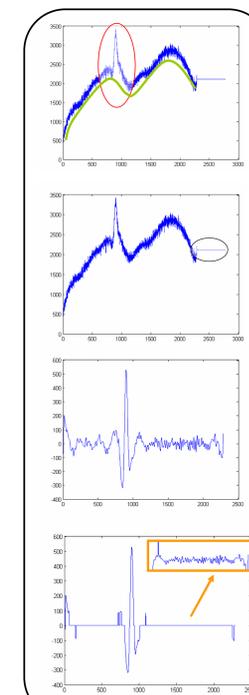
Radial Line with defect (RED) extracted from the polar representation above. In green the height variation effect

The length corresponding to the filter shift is added to the signal line

A pass band FIR filter is applied to the signal reducing significantly the height variation effect

Attenuation of the signals within the first sigma allows to highlight the defect

The result of each scan is stored in form of picture, for easy evaluation, and in form of binary data file. Starting from the data file one can generate a matrix and manipulate single rows and columns with FIR filters. This process allows for eliminating the unwanted features and enhancing possible defects.

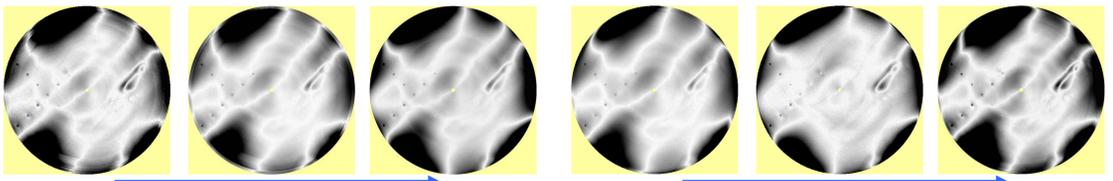
### Number of Points Acquired Test

Track dist.	200 $\mu\text{m}$	100 $\mu\text{m}$	50 $\mu\text{m}$	Track dist.	200 $\mu\text{m}$	100 $\mu\text{m}$	50 $\mu\text{m}$
Points/track	4800	4800	4800	Points/track	1600	1600	1600
Tracks	570	1140	2280	Tracks	570	1140	2280
File Mb	21 Mb	42 Mb	84 Mb	File Mb	7.1 Mb	14.2 Mb	28.4 Mb
Time scan	12 mins	24 mins	48 mins	Time scan	12 mins	24 mins	48 mins

The number of points acquired during the scan is a very important parameter in terms of device sensitivity. Due to the distance of the probe from the surface and the shape of the eddy current fields generated, the size of the signal for a 100  $\mu\text{m}$  defect is in the order of 1 mm. Comparison tests showed that the combination of 1600 points per track and 100  $\mu\text{m}$  track spacing is optimal, producing a reasonable file dimension of ~14 Mb which needs a filtering time similar to the scanning one.
