QUENCH STUDIES IN LARGE AND FINE GRAIN Nb CAVITIES*

S. Posen[†], N. R. A. Valles, M. Liepe, CLASSE, Ithaca, NY, USA

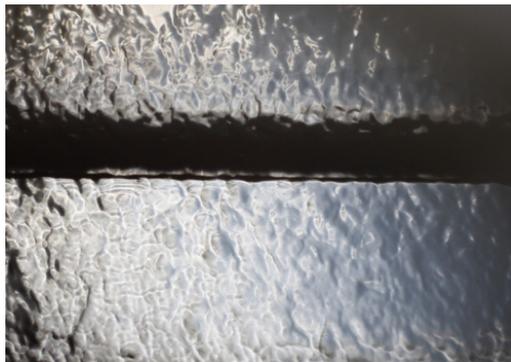
The quench location is shown in Figure 4. The rest of the cavity surface looked similar.

Figure 4: Quench location in AES02.

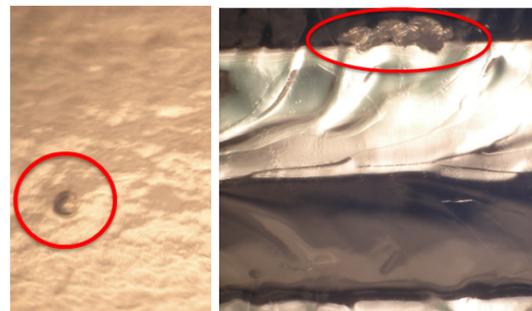
Figure 6: Defects observed in AES06 not causing quench below 30 MV/m.

The two quench locations are shown in Figure 5. A pit or bump and a scratch, both located far from the quench spots, are shown in Figure 6.

All of the fine grain cavities but one quenched without or with minimal field emission between 25 and 40 MV/m, but none showed any defects observable under optical inspection at the quench locations. In fact, AES06 and NR1-2 showed topological defects far away from the quench locations. This shows that topological defects large enough to be observed under optical inspection are not the cause of quench in these four cavities.

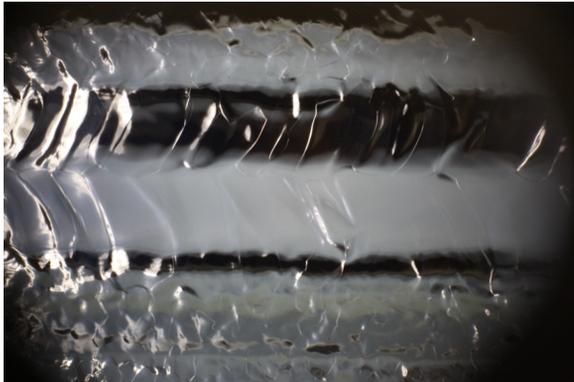
The quench location is shown in Figure 9. The rest of the cavity surface looked similar.

Figure 9: Quench location in NR1-3.

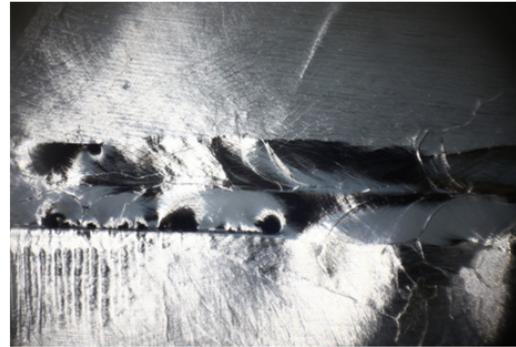
Figure 15: A typical area on the surface of LR1-6. Like the quench spot, it shows large, sharp topological features.

The quench location is shown in Figure 14. A typical area on the surface of LR1-6 is shown in Figure 15.
